Manhole Inspection Summary

Manhole # S25CC1012MH

Location Address: **1211 UNION AVE**

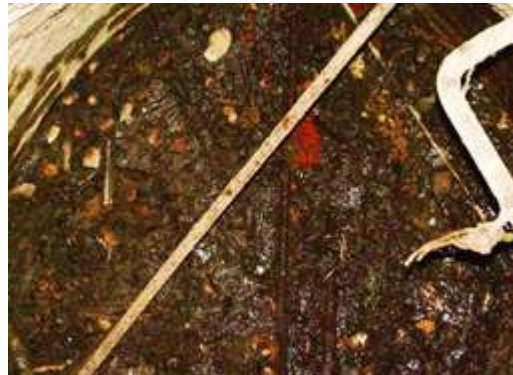
Top View

Channel debris.

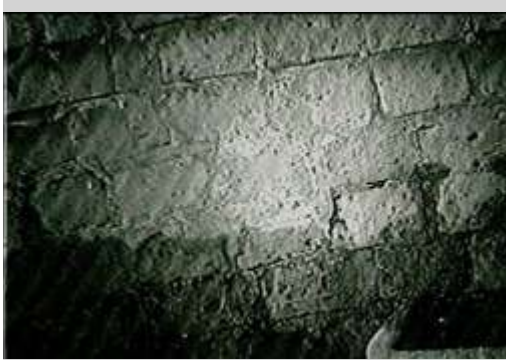
Defect

Barrel deterioration and infiltration.

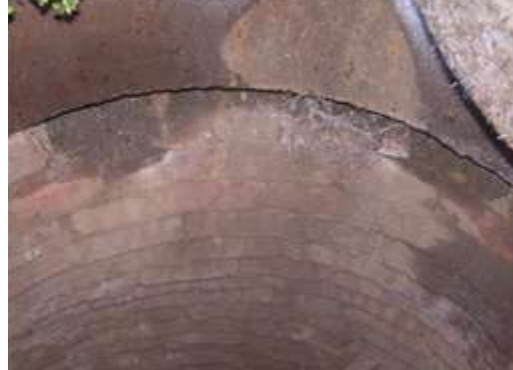
Defect

Frame leaks. Adjustment deterioration.
Adjustment, Corbel, and Barrel infiltration.

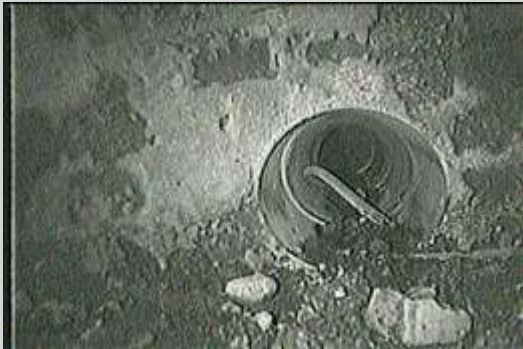
8 in. Circular Gravity Sewer
Pipe Out @ 12 O'Clock

Deposits: ☐ None ☒ **Mud** ☐ Sludge ☒ **Debris** ☐ Grease

Silt Depth: **1** (in.) Deposits Extent: **Light**

Infiltration: **Evidence** Pipe Seal Cond: **Unknown**
